# Ice conditions update: Dec 8, 2020

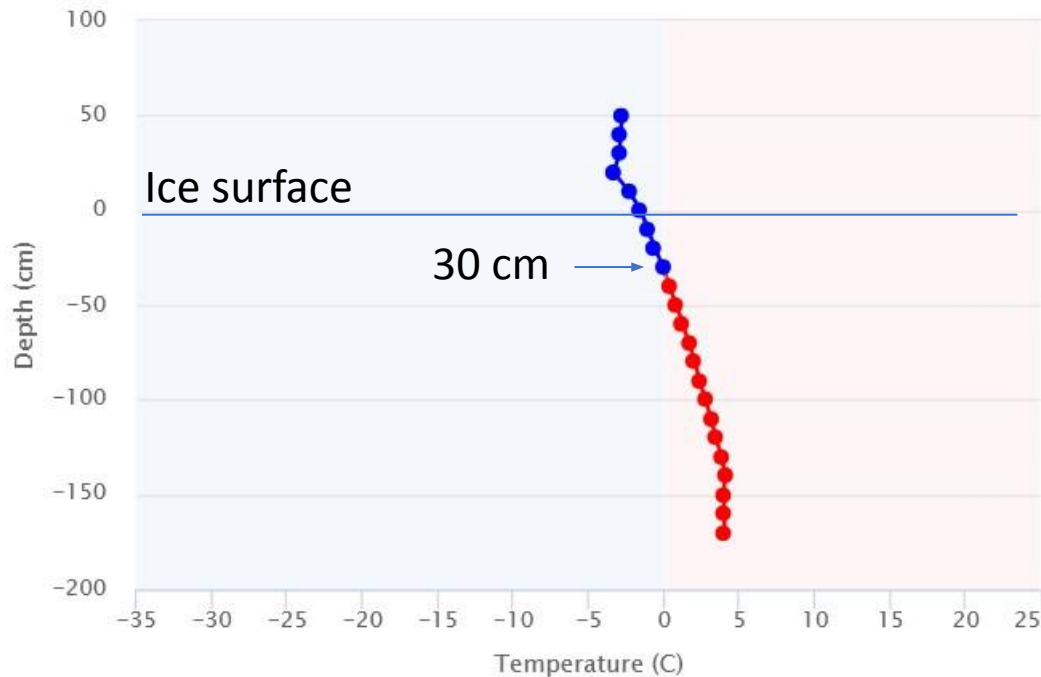
Vertical Profile

Ice thickness estimate

Dec 08, 2020 19:13:00 UTC

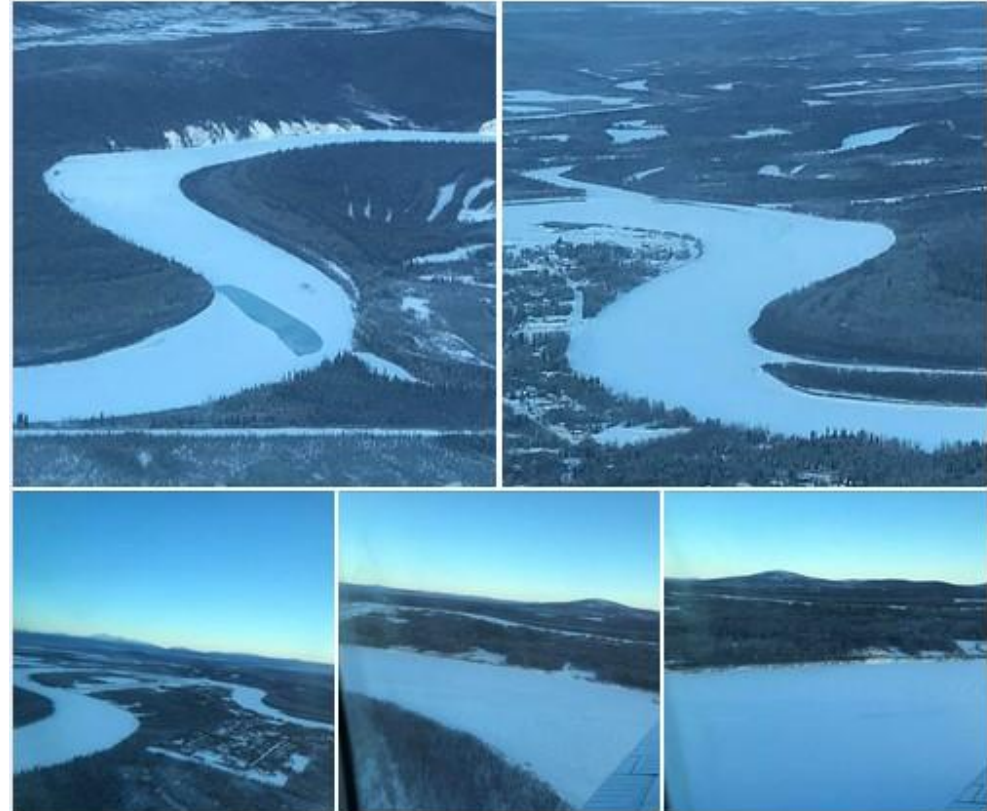
A few pictures from just above the runway in McGrath. I joined to bring a special placed based STEM opportunity to my K-2 classroom.

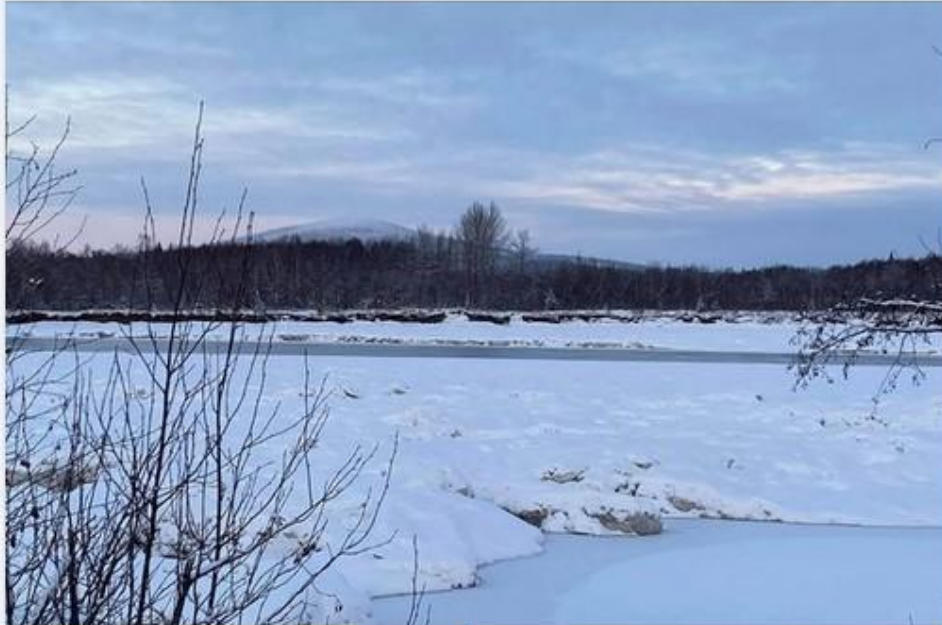
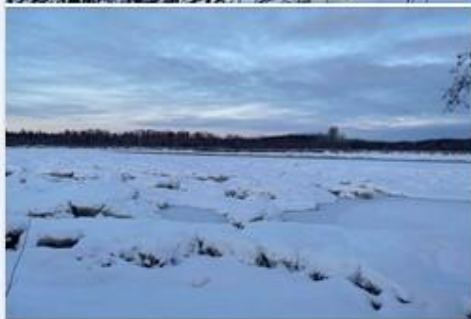
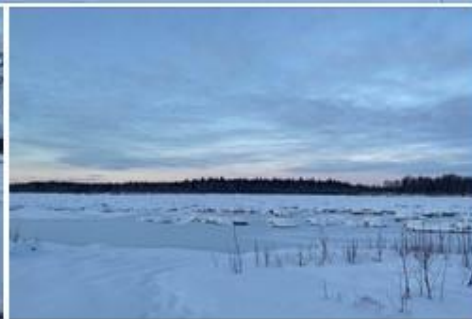
Expect rough traveling from McGrath to Takotna this year. Hoping for a good solid freeze and enough snow to even this out. (Kuskokwim River, near mouth of Takotna River)

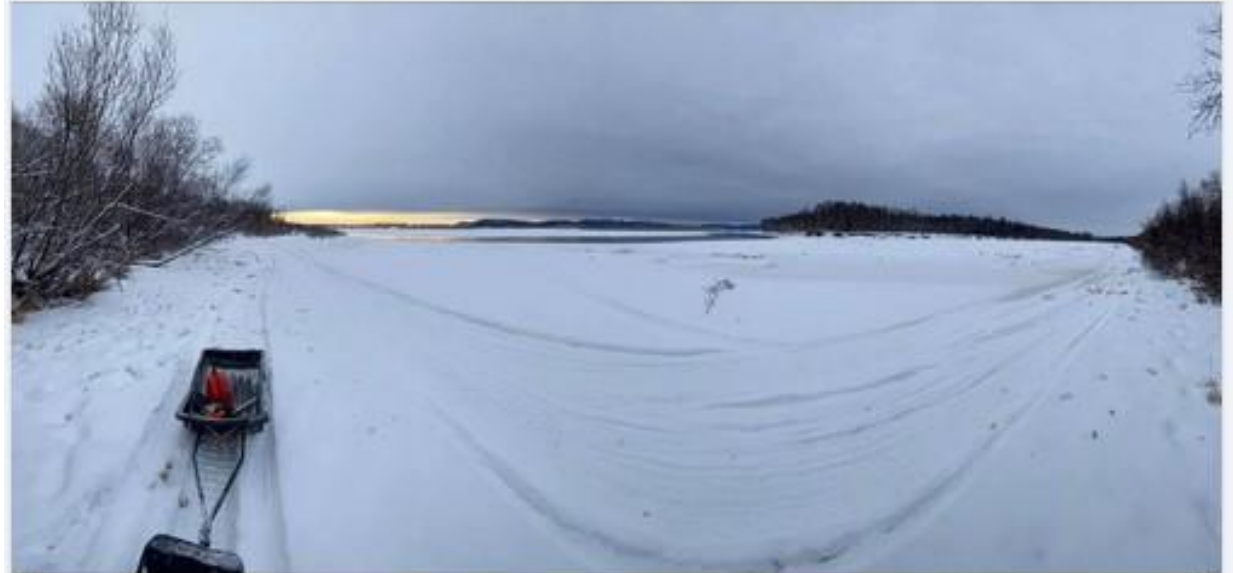
The mouth is still wide open

Description:Kuskokwim River. Weather: 16°F and snowing. Large ice chunky on sides of river (9-12 ft across / 1-2 ft thick). Open channel in center.

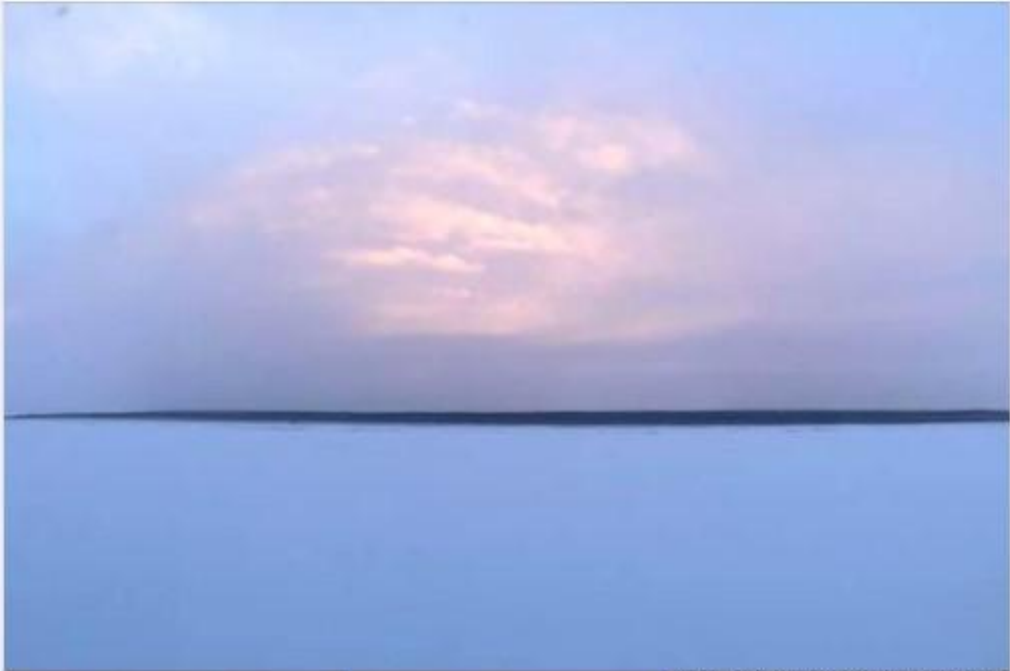
Peaceful sunrise in Bethel after a few inches of fresh snow during the night. Still not safe to travel. Enjoy break, everyone. ❄️

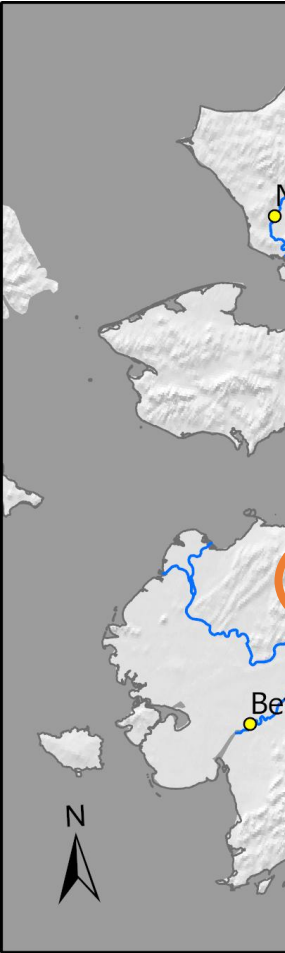
Innoko\_River\_below\_Shageluk 2020-12-07 22:01:11 UTC  
62.65298, -159.54861 12.9V -10.5°C P

Vertical Profile
